DEPARTMENT OF TRANSPORTATION
STATE OF GEORGIA

FILE: 0010925 Fulton
Riverside Drive / I-285
PI NO. 0010925

RE: Bridge Deck Condition Survey

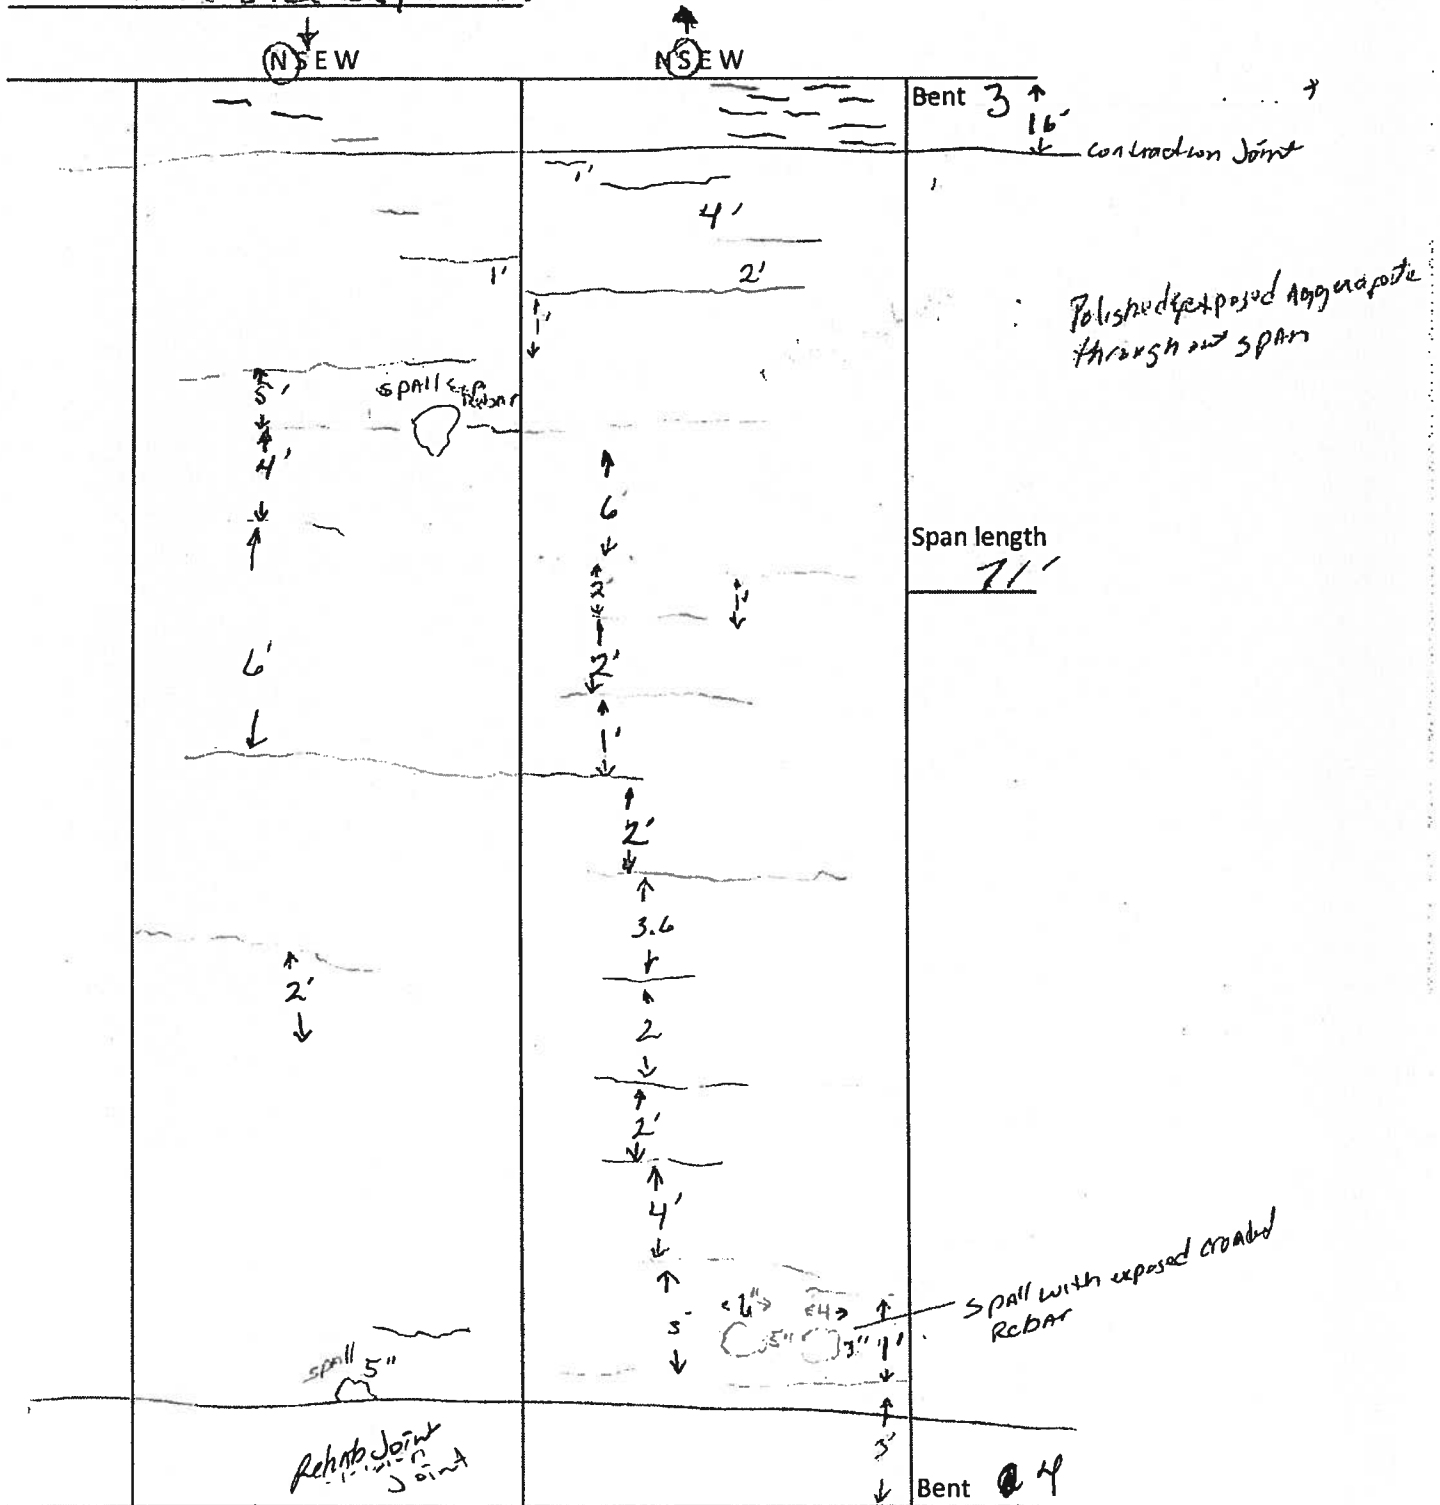
Bridge Deck Survey Drawing per spans

Span length
71'

moderate
exposed
Aggregate

Small
w/ exp.
to bar

pop outs
